NRL/MR/5673--07-9091

Fiber Optic Strain Sensors (FOSS) to Monitor Strains on a Navy Vessel During Operations

November 23, 2007

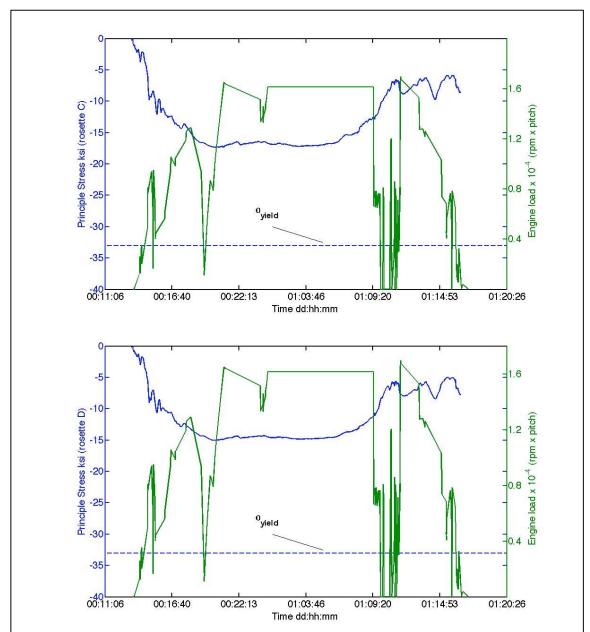
Figure 4 shows plots of the principle stresses versus time for rosettes C and D (see again Fig. 3 for rosette placement). A software glitch invalidated the results from rosettes A and B as well as the thermal compensation sensor. Thus the results shown in Fig. 4 do not have thermal effects in the optical fiber removed. In this figure note that the measured stresses are all compressive, with the largest magnitudes beginning about 2000 hours and ending near 0600 the next morning. Also plotted is a measure of engine load (shaft rpm x pitch). During transit we noticed that the observed strains seemed to correlate somewhat with speed. Indeed, the data shows a strong correlation between engine load and deckplate compressive stress. As the ship picks up speed, the stress observed in the deckplate tends to increase. This may be due to thermal loading from the engine transferring to and stabilizing in the ship structure or perhaps direct structural loading resulting from drag created by speed increases. Regardless, a phenomena showing strong correlation to engine load appears to be at least one of the primary mechanisms causing excessive stress in the deckplate. Also plotted in Fig. 4 is the yield stress for the deckplate material.

Based on the data, it appears the deckplate stress is roughly ½ the yield stress (32ksi).

Figure 4. Principle stresses recorded during the trip from rosettes C & D. Also shown is the yield stress for the deck material. Note that the largest stresses began near sunset on 6/7/07 and ended about sunrise on 6/8/07. Stress correlates well with engine load.

It's also worth noting that the maximum principle stresses are similar for both rosettes while the minimum strains differ significantly. This indicates that the mean strain is varying across the plate. It's also important to understand that there is no way of knowing what residual stresses existed in the deckplate at the time that our measurements were started. Thus, the deckplate may have initially been in tension and could have possibly remained in tension for the trip duration (depending on how large the initial tension was). It is also possible that the deckplate could have experienced some combination of initial tension changing to compression and back. Nevertheless, the variations in strain magnitude, up to 50% yield of the base metal, indicate a [predicted] cyclic phenomenon that appears to correlate to engine load.

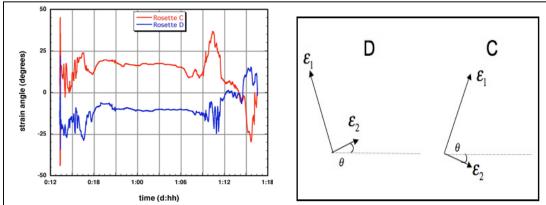
Figure (5) shows a plot of the strain angles corresponding to rosettes C and D. For much of the trip the strain angles were roughly $\pm 20^{\circ}$. The resulting directions of maximal strain are such that a large amount of shear may be occurring on the plate (see right plot of Fig. (5)).

Figure 5. Principle strain angles measured during the trip by rosettes C (red) and D (blue). The right plot is a rough illustration of the principle strain directions as measured from sunset on 6/7/07 to sunrise on 6/8/07

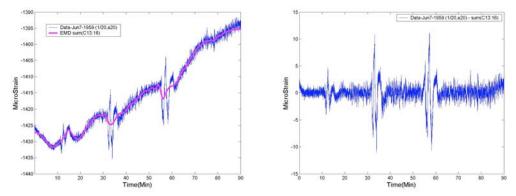
Figure 6 displays the sequence of data recorded during maneuvers. The left plot indicates the raw data as recorded by the FOSS. The right plot shows the data after application of an Empirical Model Decomposition (EMD) to remove the trend. The time axis shown in Figure 6 is shown relative to the beginning of the maneuvers. Table (1) lists the speeds (in knots). Several observations can be made regarding the deckplate response to high speed turns. First and foremost, the maximum strains observed due to the ship maneuvers were roughly $\pm 10~\mu$ E. These values are extremely small and are not likely to be the cause of any significant structural damage. Although the magnitude of the strain values do increase with speed, the ship will not likely see maximum knots for prolonged periods thus we do not expect hard turns at speed to be an issue. A minor point of interest concerns the ambient noise associated with the engine vibration.

Figure 6. Raw sensor data recorded from sensor 3 of rosette C showing the strain values recorded during the series of turns (left). Data with trend removal using EMD signal processing technique (right).

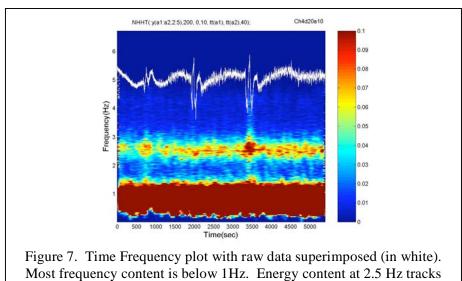
Clearly as the speed of the ship is increased the ambient engine noise is also increased and is captured nicely by the sensors. This affect can also be observed in the time-frequency plot of Figure (7). The detrended signal is superimposed (in white) in order to highlight the influence of the maneuvers on frequency content. Clearly there is an increase in energy at roughly 2.5 Hz during the turns, but also a small, but observable, increase due to ambient engine noise as the speed is ramped up.

well with ship maneuvers.
